Initial Feasibility Analysis Report

For Flood Control at Foxcroft Colony Condominiums and
Mosby Woods Condominiums, and Stream Restoration at Daniels Run

City of Fairfax, Virginia

May 2013

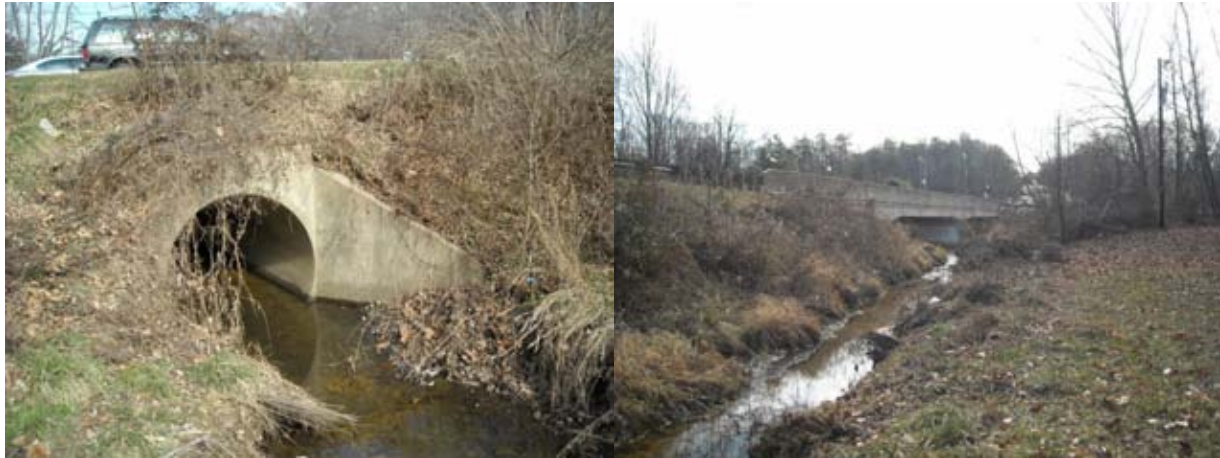
Figure 3-2. Photographs of Culvert System and Drainage Ditch Connecting to Accotink Creek

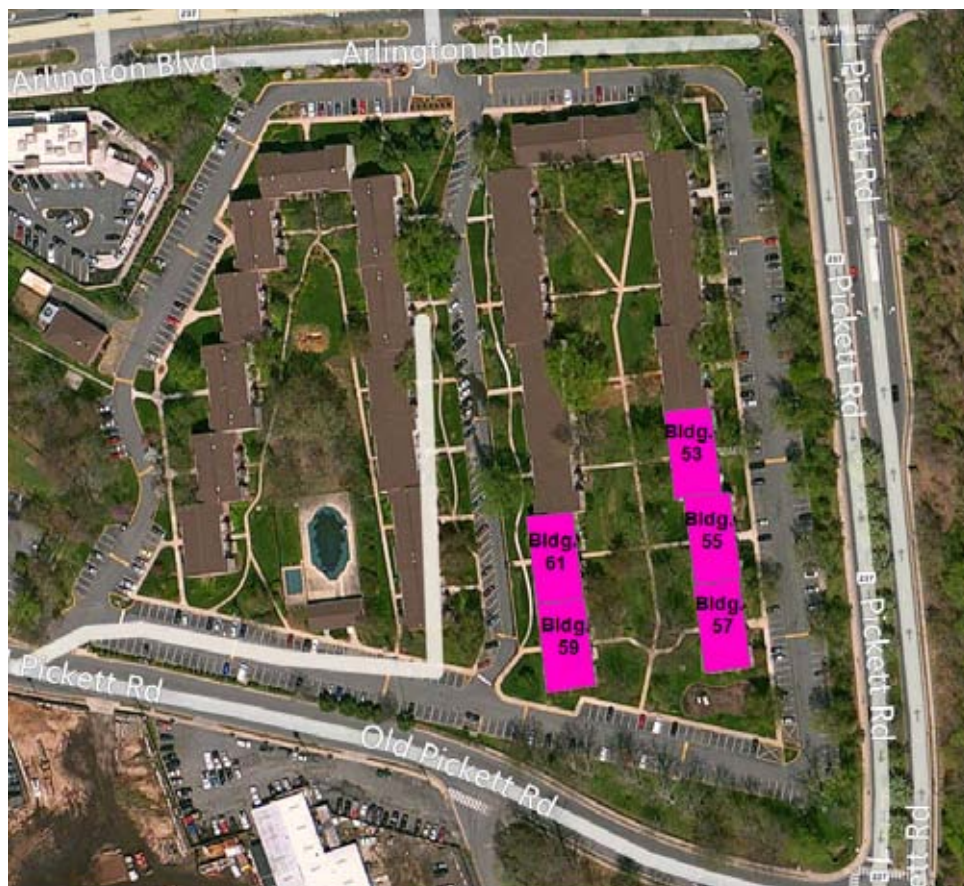
Figure 3-3. Buildings Affected by Historical Flooding at the Foxcroft Colony Condominiums

The most recent rainfall event was Hurricane Sandy on October 26, 2012. A year prior, Tropical Storm Lee caused major flooding on September 8, 2011 where 12 of the 312 condominium units, as well as the common area of five buildings, were flooded with over 10 inches of water. Refer to **Figure 3-3** indicating buildings at Foxcroft Colony that have experienced flooding during the 2011 flooding event.

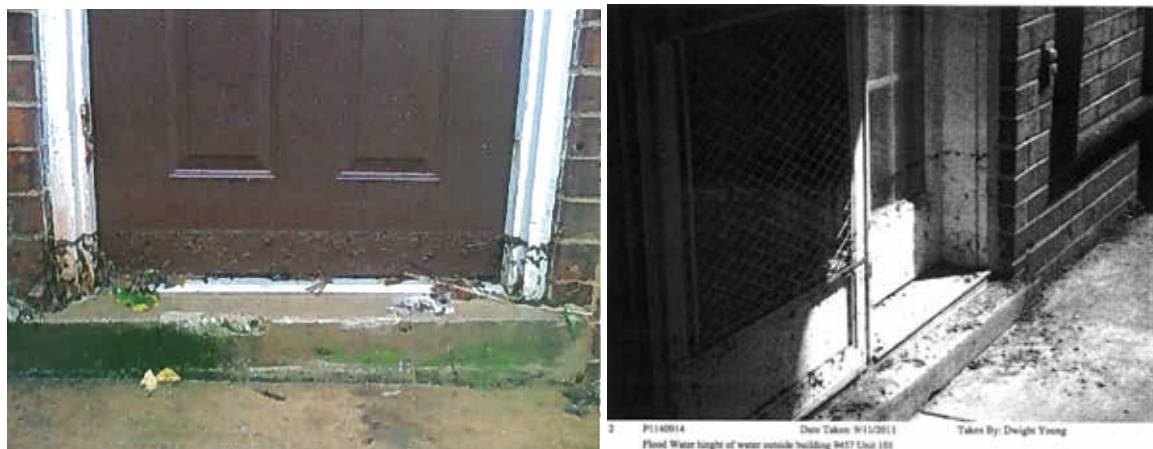
Figure 3-4. Evidence of High Water Marks from 2011 Flooding at the Foxcroft Colony Condominiums

Photographs showing evidence of flooding during Tropical Storm Lee in 2011 at Foxcroft Colony are shown in **Figure 3-4**.

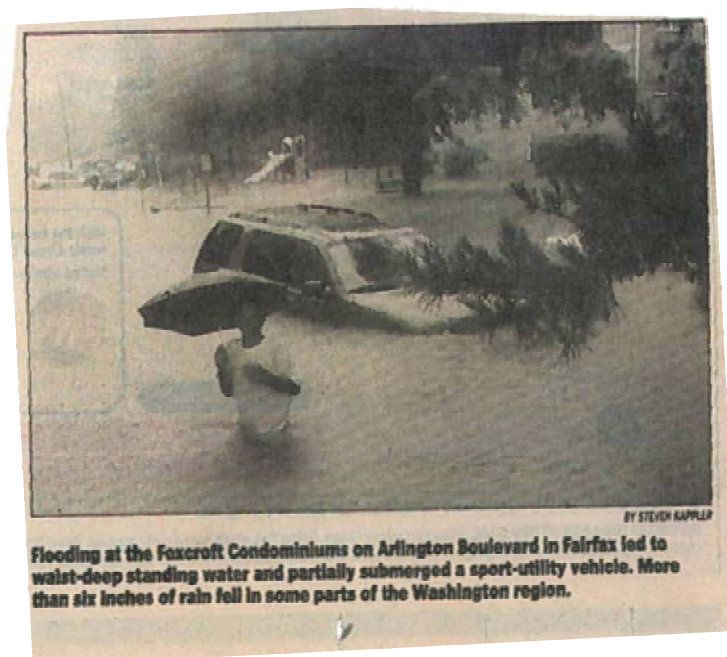
Figure 3-5. Photograph of Flooding during Hurricane Hanna at the Foxcroft Colony Condominiums

On September 6, 2008, Hurricane Hanna caused significant damage and flooding to 8 first-floor units in Buildings No. 55, No. 57 and No. 59 as well as inundating the southeast section of the community grounds and Old Pickett Road with several feet of water. A photograph from the Washington Post is provided in **Figure 3-5** showing flooding of the Foxcroft Colony southeastern parking lot area during Hurricane Hanna.

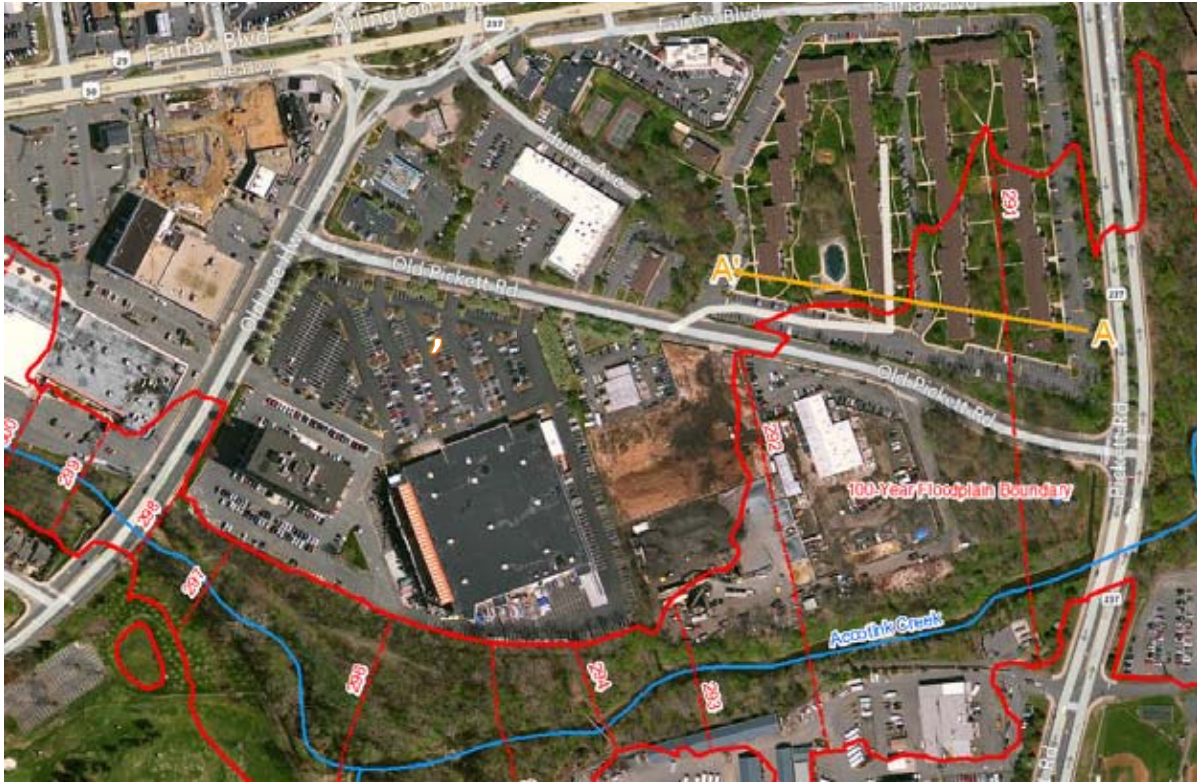
Figure 3-7. 100-Year Flood Boundary and BFEs at the Foxcroft Colony Condominiums

The condominiums shown in the graph are those along the transect A'-A and are shown in **Figure 3-7**. Because the finished floor elevations of the buildings were not available, this study relied on interpolating the lowest adjacent grade for each building based on topographic 2-foot interval contours GIS data provided by the City of Fairfax. The GIS data provided by the City is in vertical datum NAVD 1988.

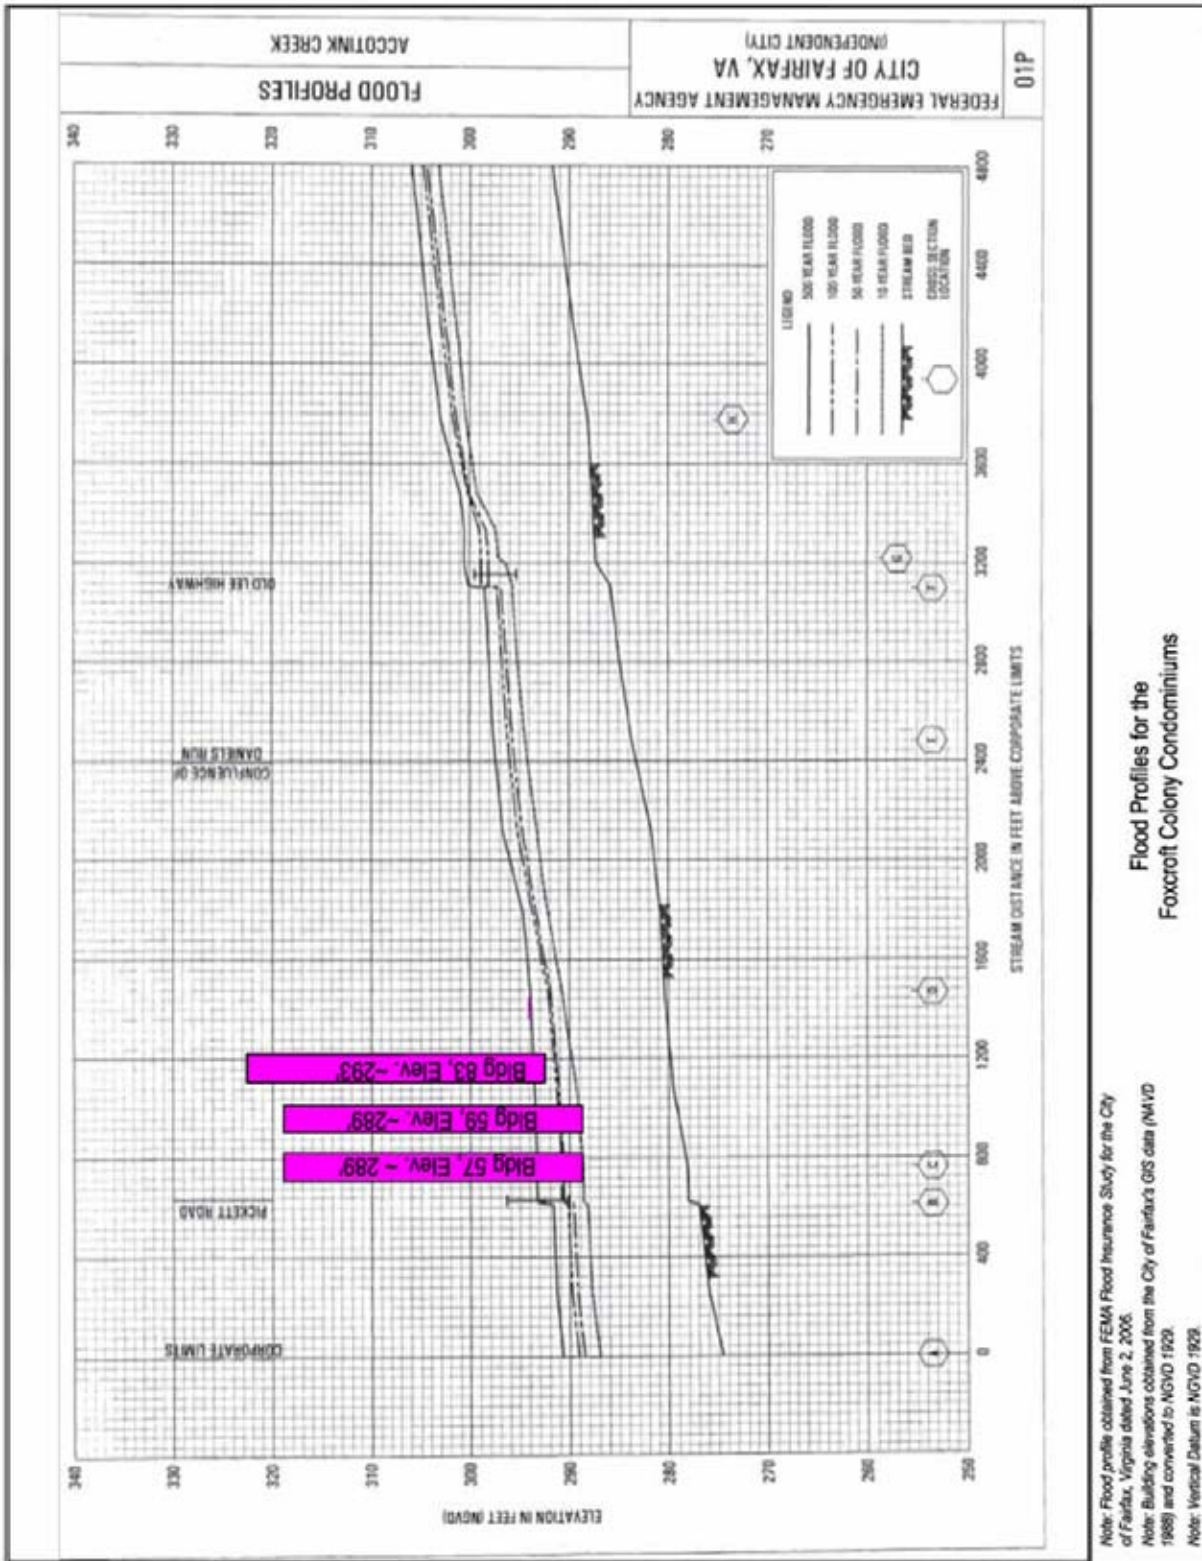
Figure 3-8. FEMA Flood Profiles for Accotink Creek with Foxcroft Colony Condominium Buildings

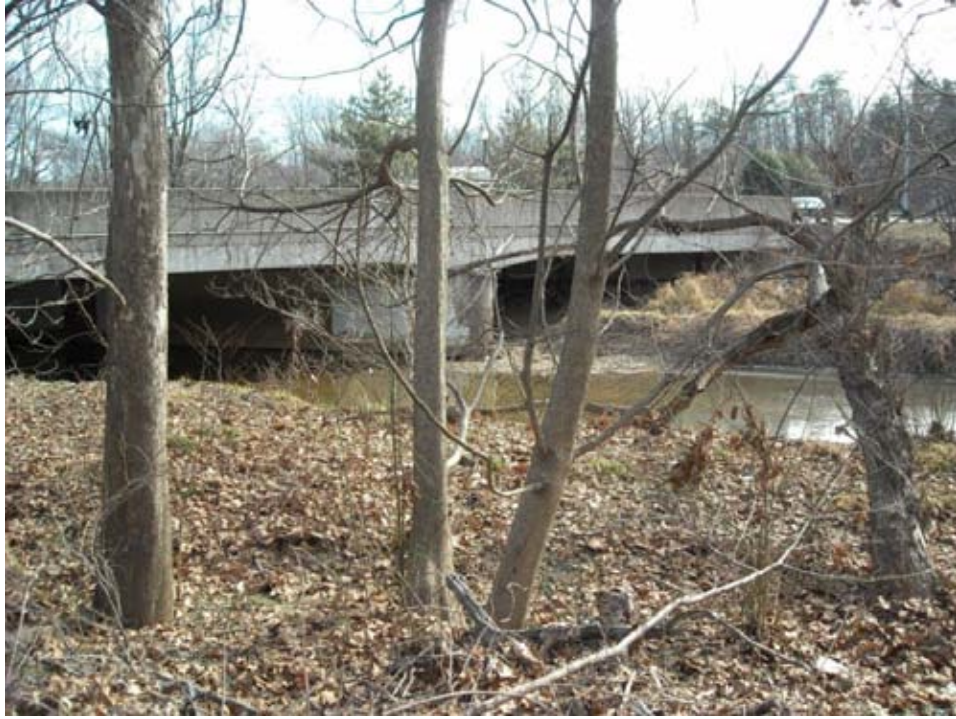
Figure 3-9. Pickett Road Bridge Crossing Over Accotink Creek (January 2013)

URS personnel performed field reconnaissance in January 2013 to investigate conditions of the Foxcroft Colony Condominium study area. During this investigation it was noted that a significant amount of sediment has been deposited in the Accotink Creek immediately upstream of Pickett Road Bridge crossing (refer to **Figure 3-9** and **Figure 3-10** showing conditions as of January 2013).

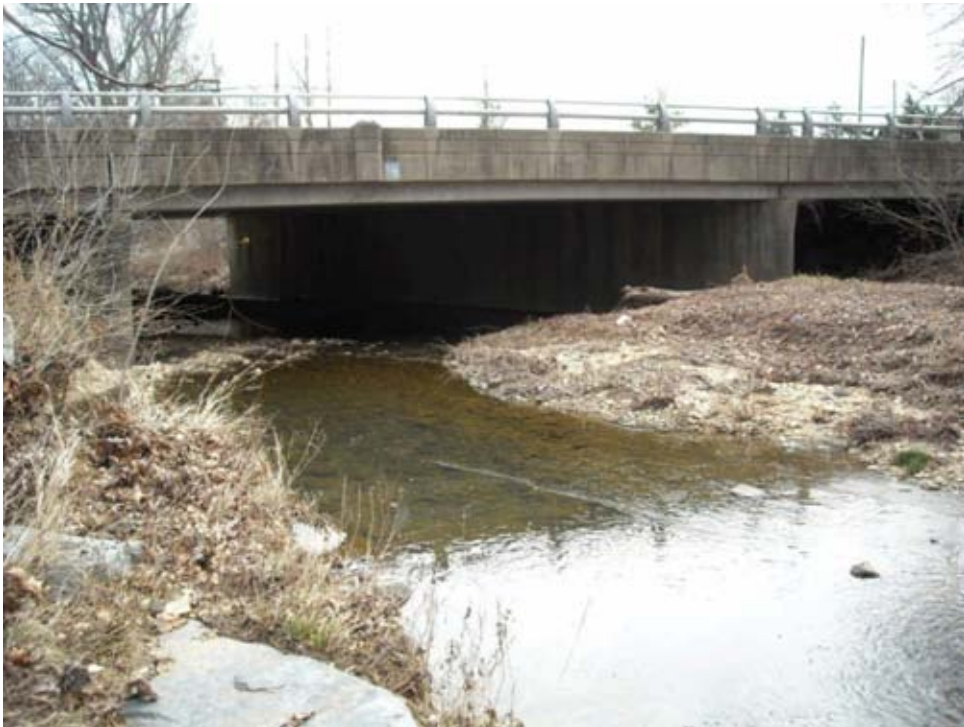
Figure 3-10. Pickett Road Bridge Crossing Over Accotink Creek (January 2013)

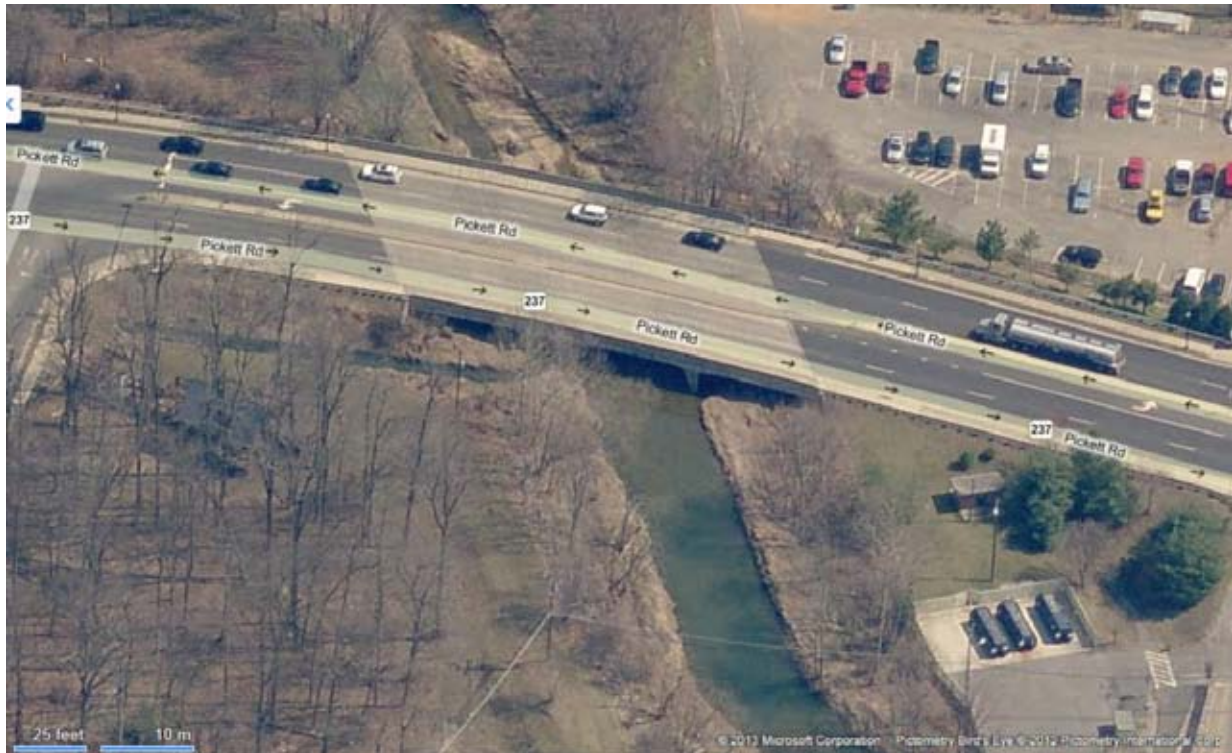
Figure 3-11. 2012 Birds Eye View Aerial Imagery of Pickett Road Bridge Crossing at Accotink Creek

For comparison, aerial imagery retrieved from Bing.com (**Figure 3-11**) shows conditions of the Accotink Creek without sediment deposited in the creek immediately upstream of the bridge crossing. The sourced aerial imagery from Bing.com is undated.

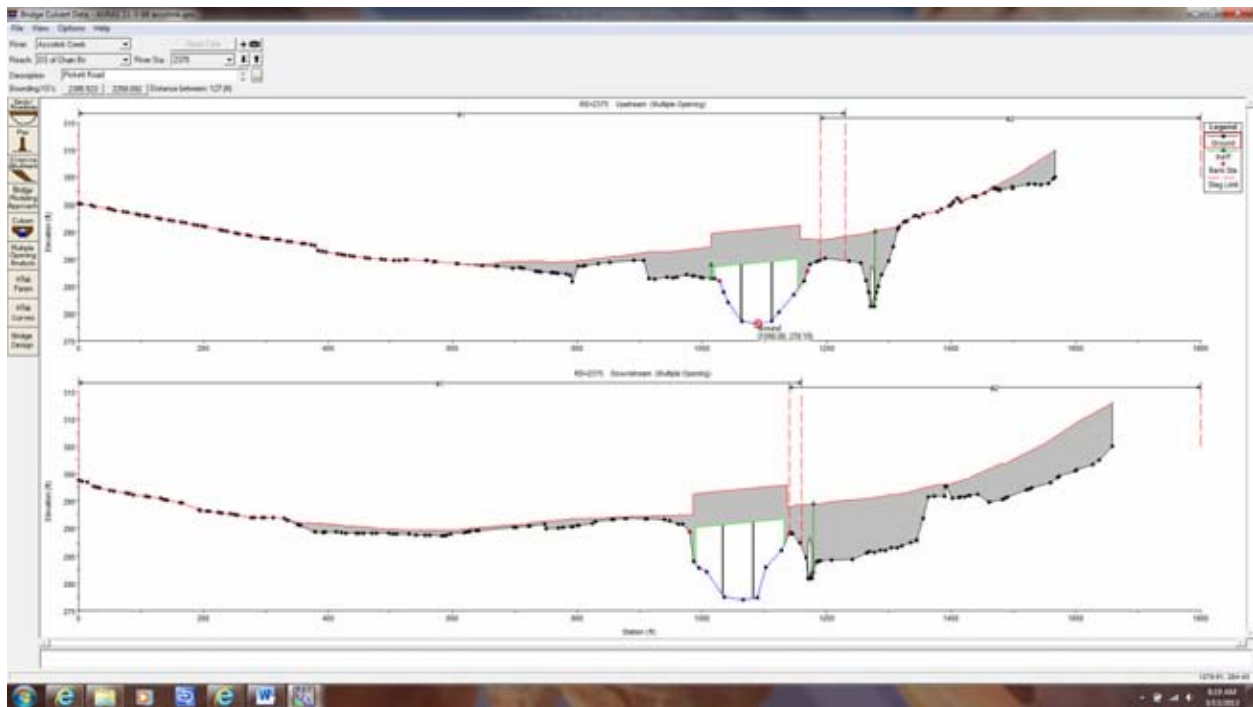
Figure 3-13. Full Cross-Section of Pickett Road over Accotink Creek from FEMA HEC-RAS Model

It is evident from reviewing the bridge design plans and the FEMA HEC-RAS model that the current conditions of the Accotink Creek at the Pickett Road crossing differs considerably due to excess sedimentation in the creek. Without a field survey, there is no way to know the amount of sediment accumulation immediately upstream of the bridge; however, based on field observation, it is believed that there is enough accumulation of sediment and debris to reduce the flow at the bridge during larger rain events. This accumulation may be causing the attenuation of floodwaters upstream of the Pickett Road Bridge crossing which in turn causes additional flooding of the floodplain at Foxcroft Colony. This accumulation may be a contributing factor as to why Foxcroft Colony has experienced increased flooding over the past several years.

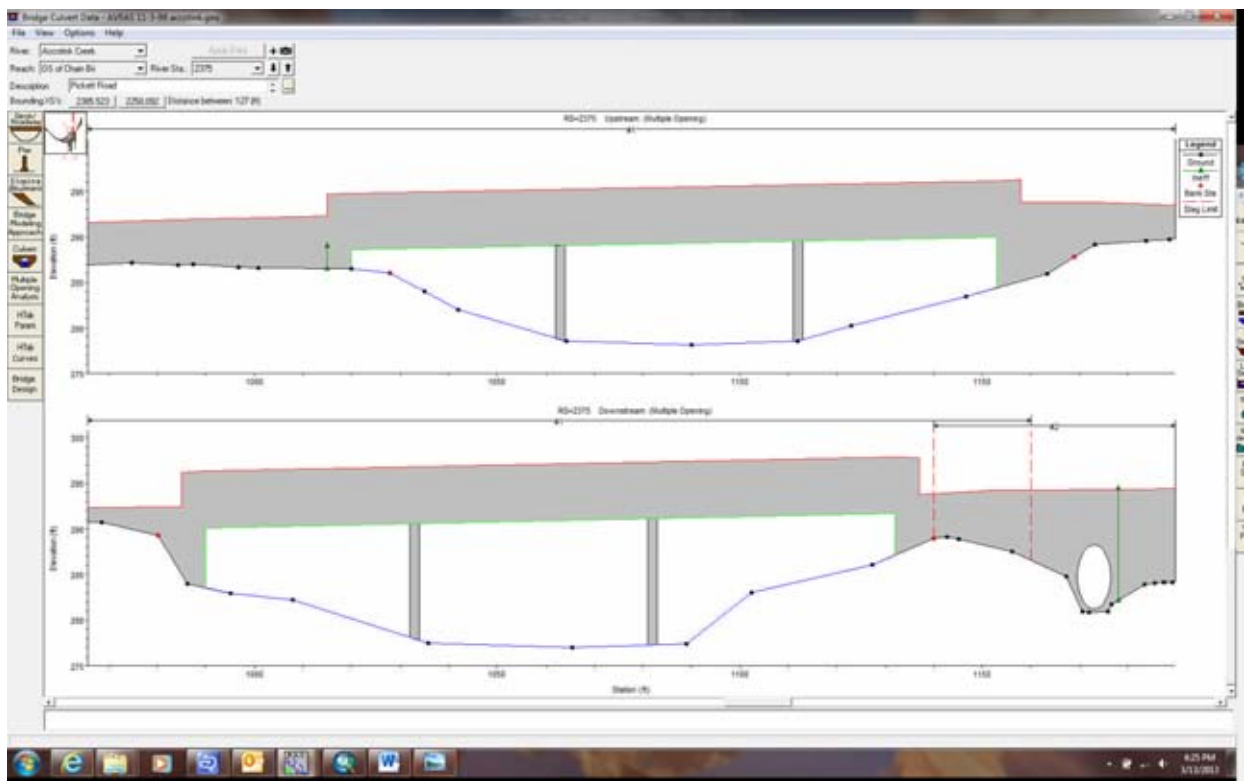
Figure 3-14. Pickett Road Bridge Opening over Accotink Creek from FEMA HEC-RAS Model

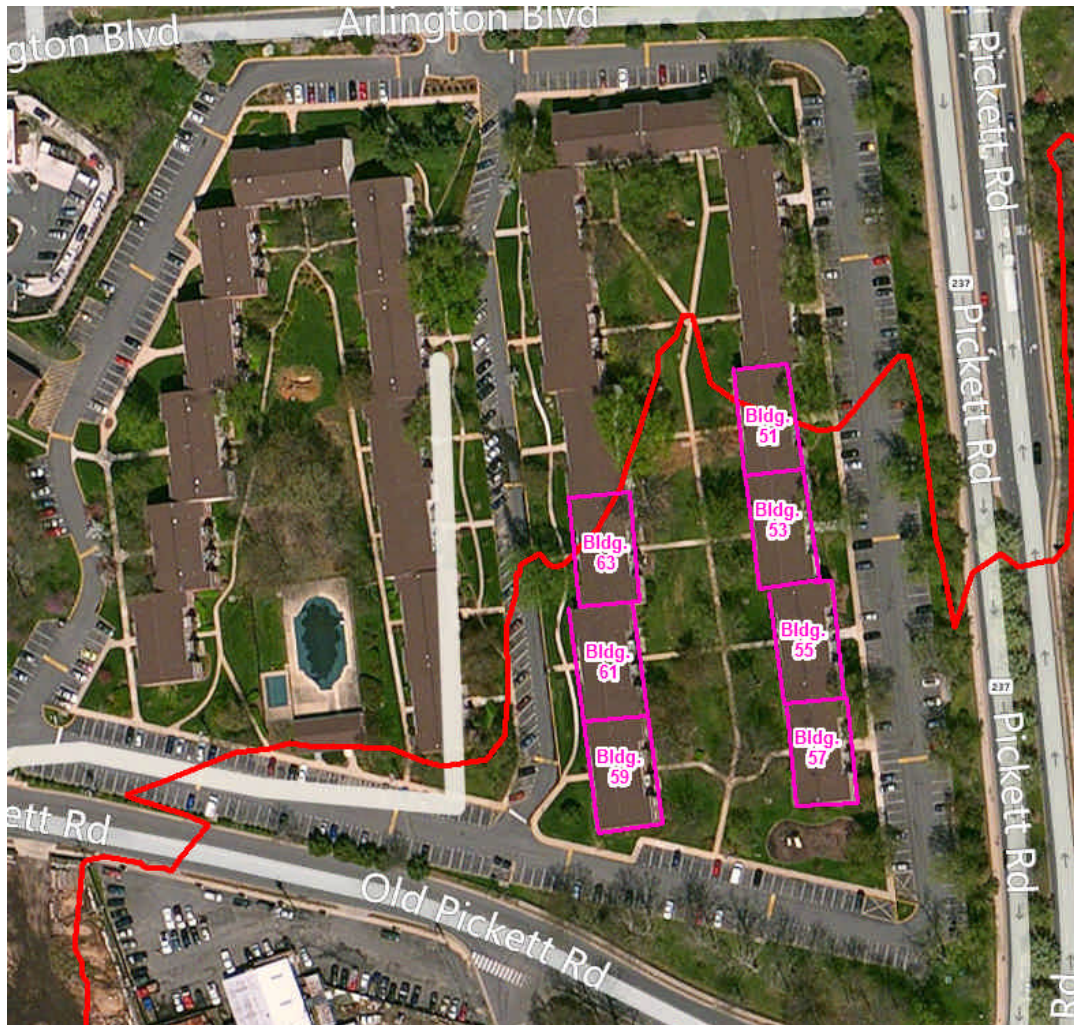
Figure 3-15. Foxcroft Colony Condominium Buildings to be Flood-proofed

Proposed Alternative Plan 1 consists of flood-proofing the buildings of Foxcroft Colony within the designated floodplain. Based on the effective FEMA FIRM, there are 28 first-floor condominium units in 7 buildings located in the 100-year floodplain, as shown in **Figure 3-15**. During past flood events flood waters have entered several of these units through the garden patio doors and the common utility room doors. Water has then traveled from the garden units through interior walls to adjacent units on the first floor.

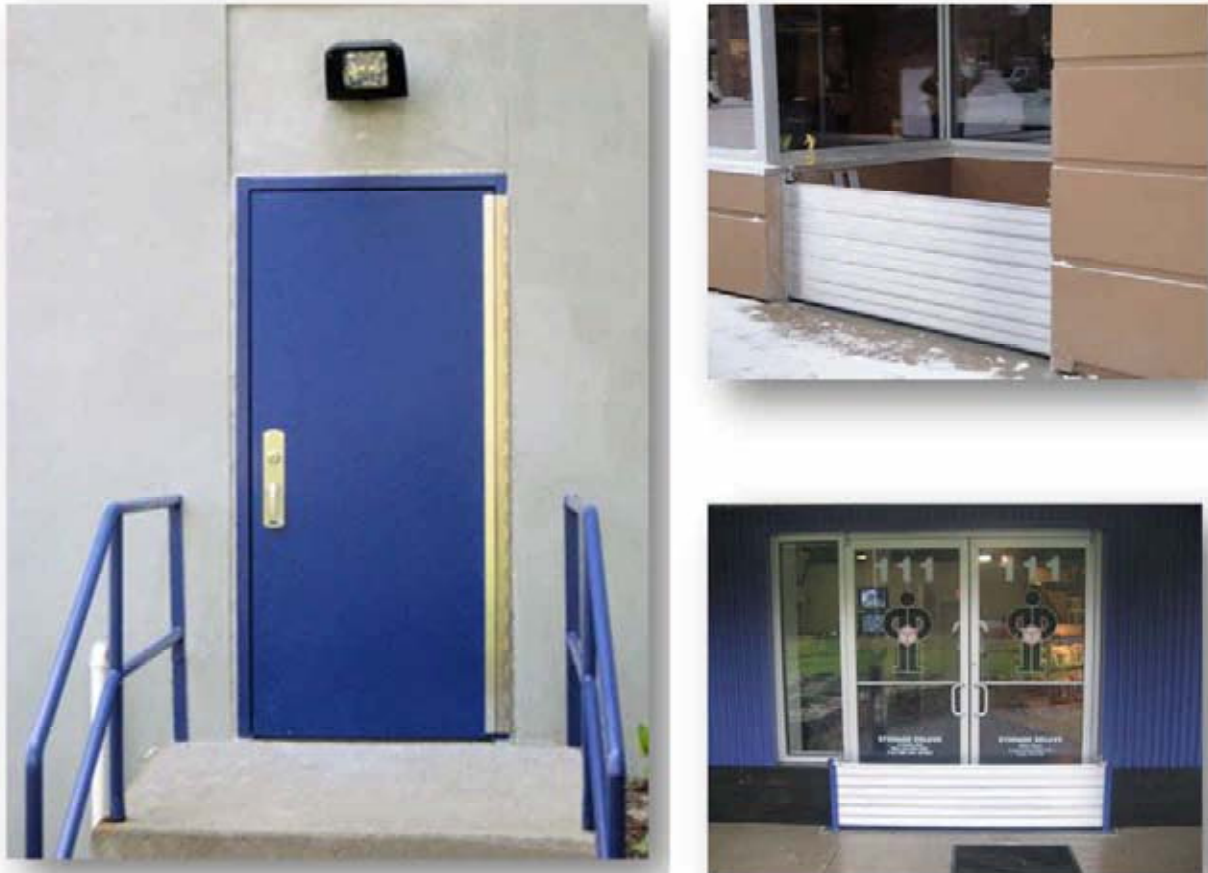
Door manufactured by PS Doors. This door is a pre-hung normal use pedestrian door that also acts as a flood protection door. As long as the door is closed and latched, the area behind the door is protected from flooding. This type of door would work well for the entrance to the common utility room areas located on the first floor of each building and would replace the existing doors. Using a flood barrier plank system is an economical way to provide water protection to doors or openings when you want flood protection at the time of need only. Flood planks are a choice when it is not desirable or possible to store a flood barrier in a door or opening.

Figure 3-16. Typical Examples of Flood-proofing Doors and Barriers

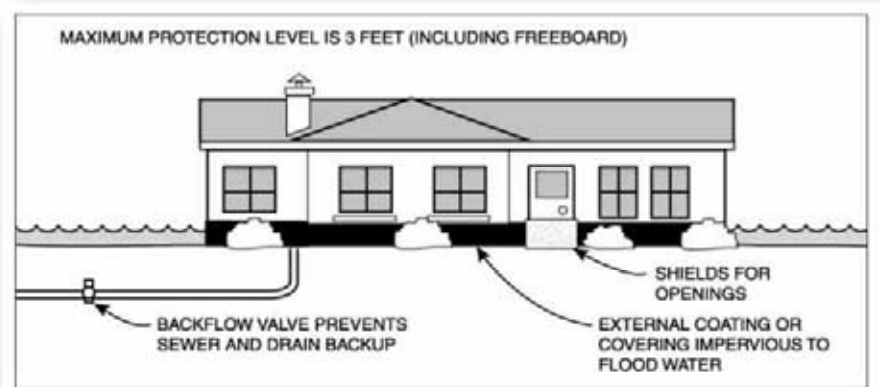
Generally, dry flood-proofing should only be employed on buildings constructed of concrete block or brick on a wood frame. Weaker construction materials may fail at much lower water depths from hydrostatic pressure. Even brick or concrete block walls should not be flood-proofed above a height of approximately three feet, due to the danger of structural failure from hydrostatic forces, unless a structural engineer has confirmed that the building is designed to handle the forces.

Figure 3-17. A Typical Dry Flood-proofed Structure

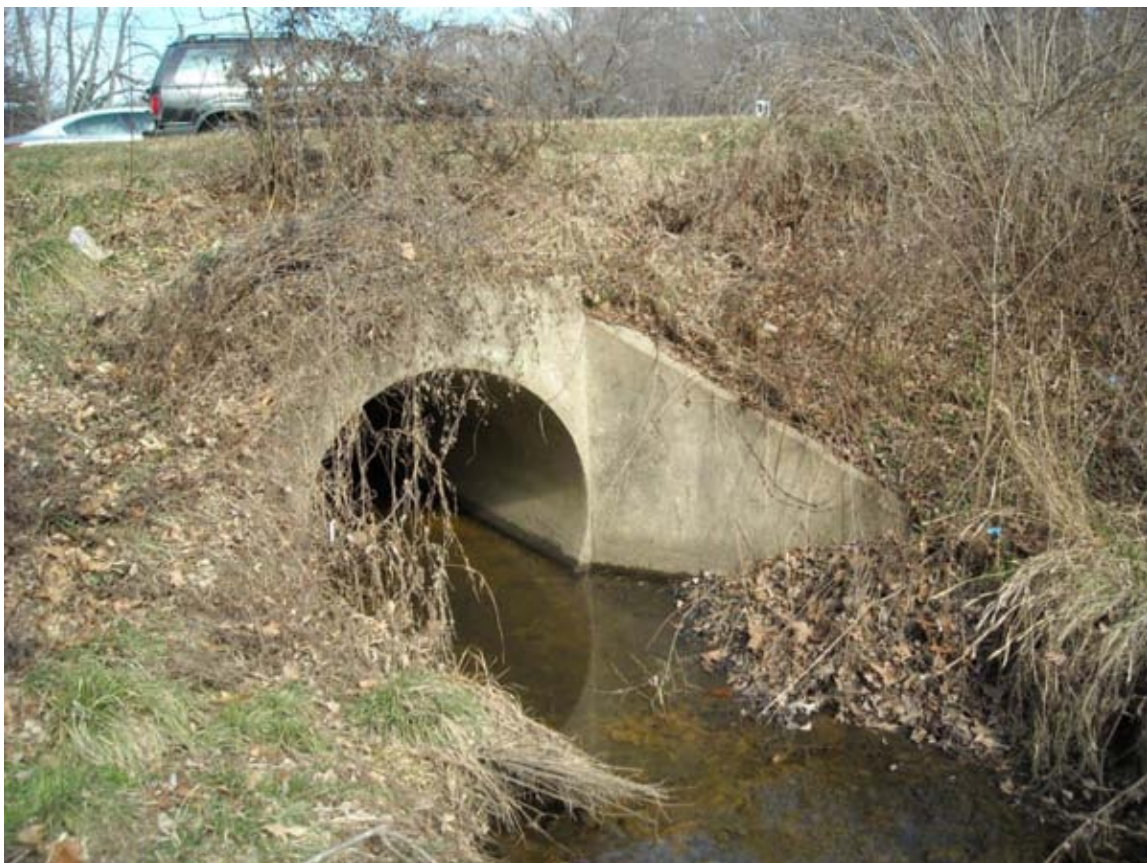
Figure 3-18. Culvert under Old Pickett Road at Intersection with Pickett Road

Proposed Alternative Plan 2 consists minor localized drainage improvements to increase the conveyance of flow on the Accotink Creek in the vicinity of Pickett Road Bridge by dredging the and installing a device backflow prevention device to prevent floodwater from the Accotink Creek floodplain at the culvert on the south side of Old Pickett Road (shown in **Figure 3-18**).

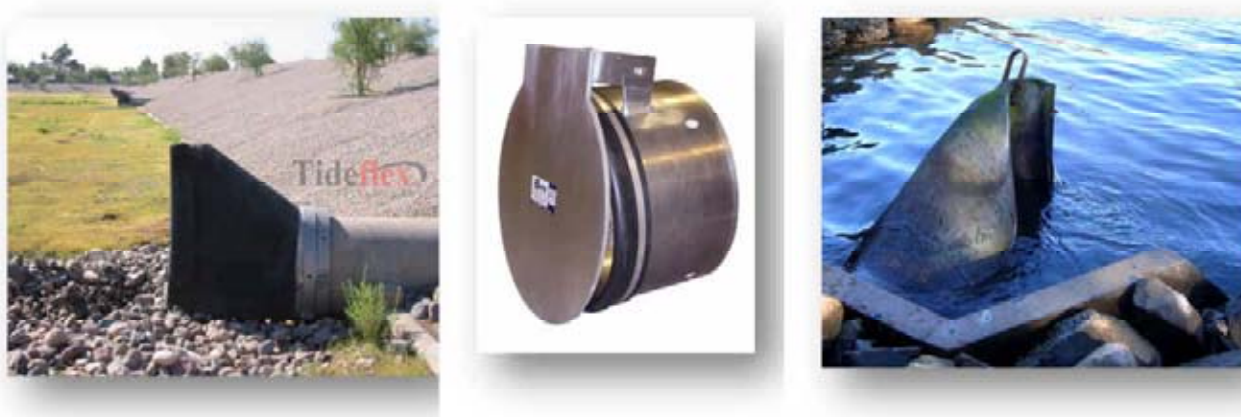
Figure 3-19. Typical Examples of Stormwater Backflow Prevention Valve and Gate Devices
(Sources: <http://www.tideflex.com>, <http://www.awma.au.com/>)

Installing a backflow prevention device such as a gate or valve, similar to the examples shown in **Figure 3-19** below would prevent flood waters from entering the Foxcroft Colony community from the existing drainage ditch and culvert system at the intersection of Old Pickett Road and Pickett Road. Storm events equivalent to and less than the 10-year event do not overtop Old Pickett Road therefore the

As discussed previously, stormwater runoff will raise the water level in the Accotink Creek and the drainage ditch immediately upstream of Pickett Road hydraulically connecting the Foxcroft Colony community storm sewer lines to the Accotink Creek. Installing a backflow prevention gate or valve, similar to the examples shown in **Figure 3-19**, would reduce the flood waters entering the Foxcroft Colony community from the existing drainage ditch and culvert system at the intersection of Old Pickett Road and Pickett Road.

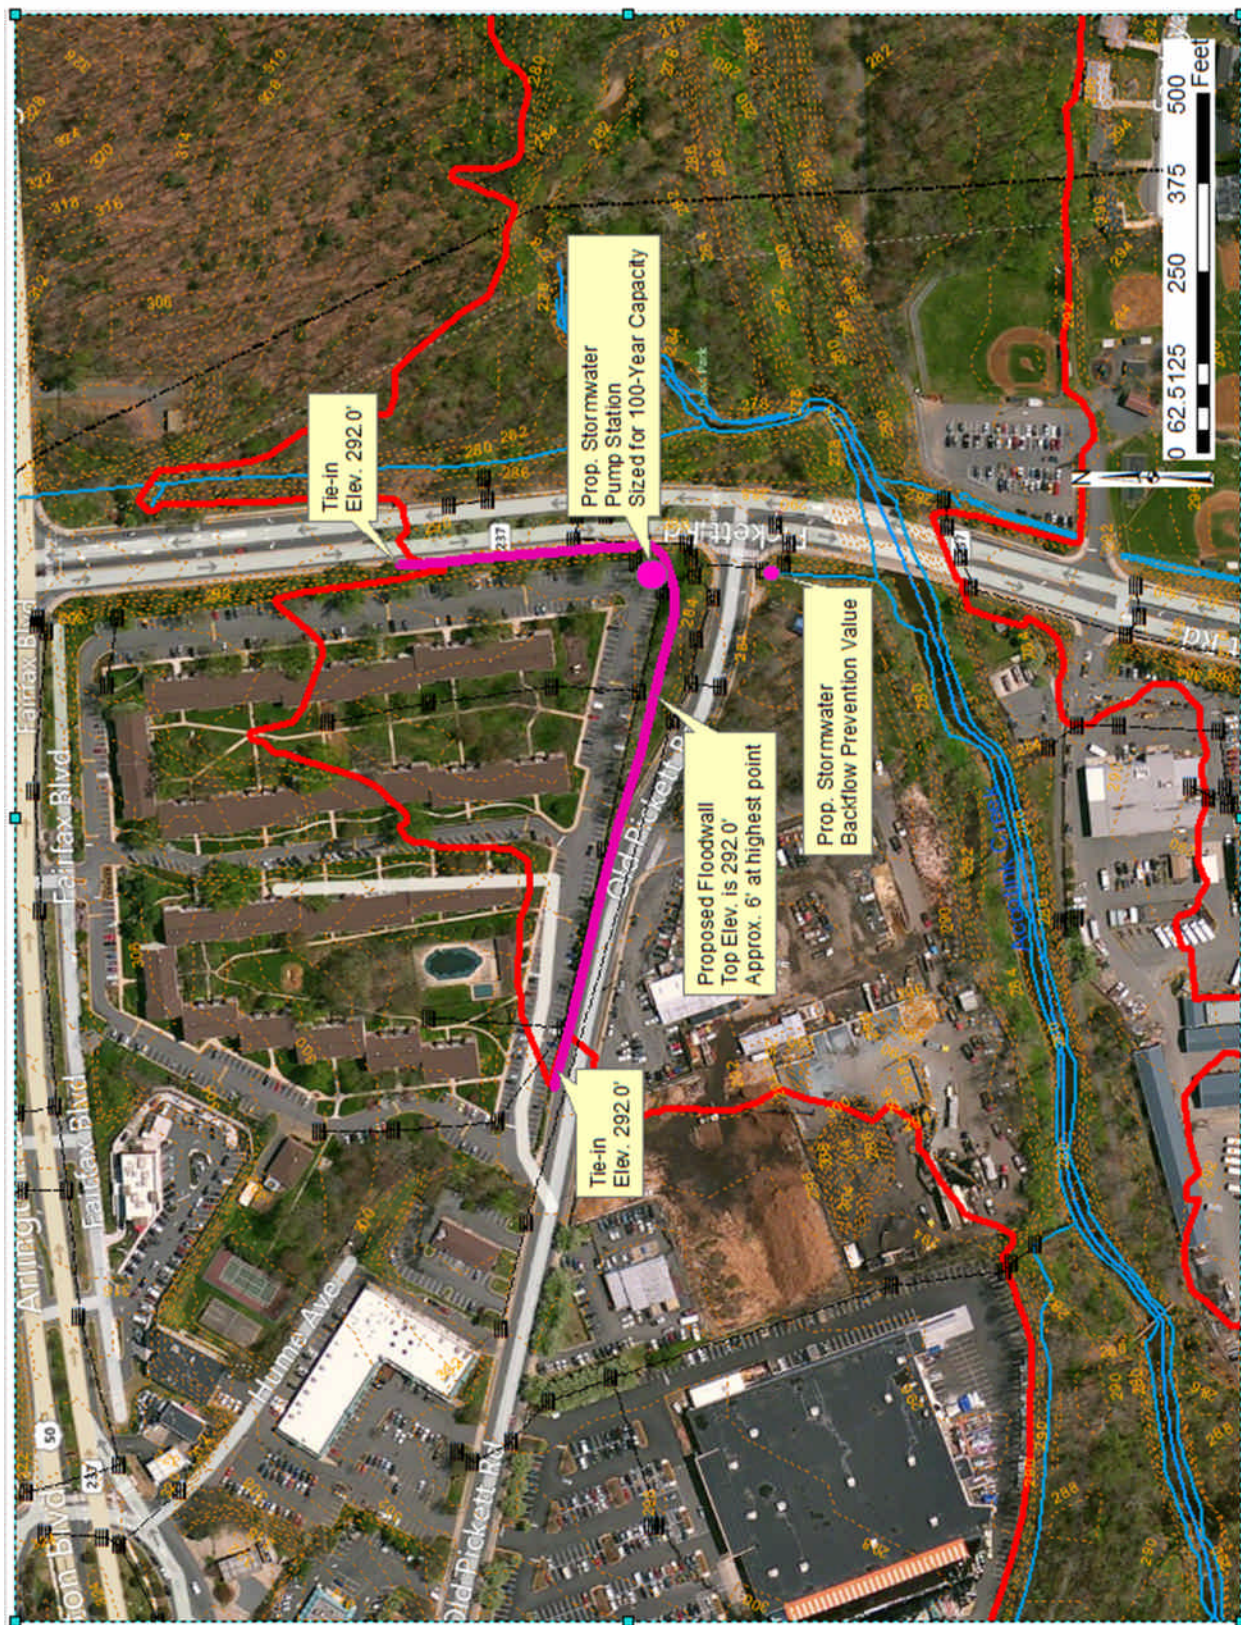
Figure 3-20. Proposed Concept Plan – Alternative Plan 3 Floodwall and Pump Station

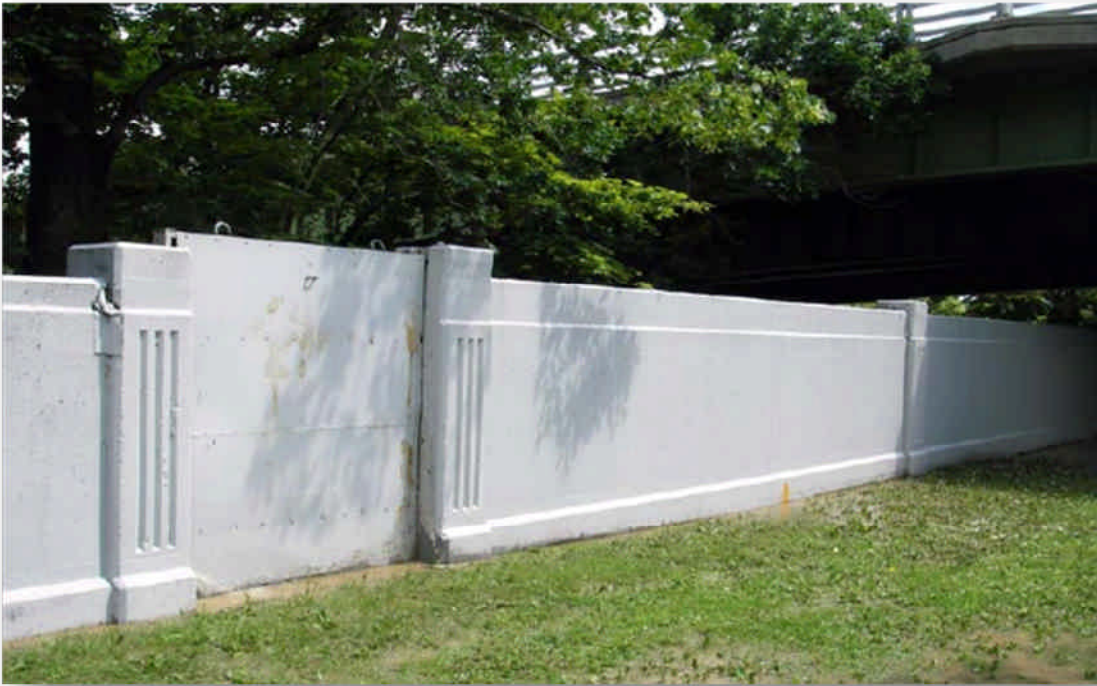
Figure 3-21. Example of Typical Floodwall

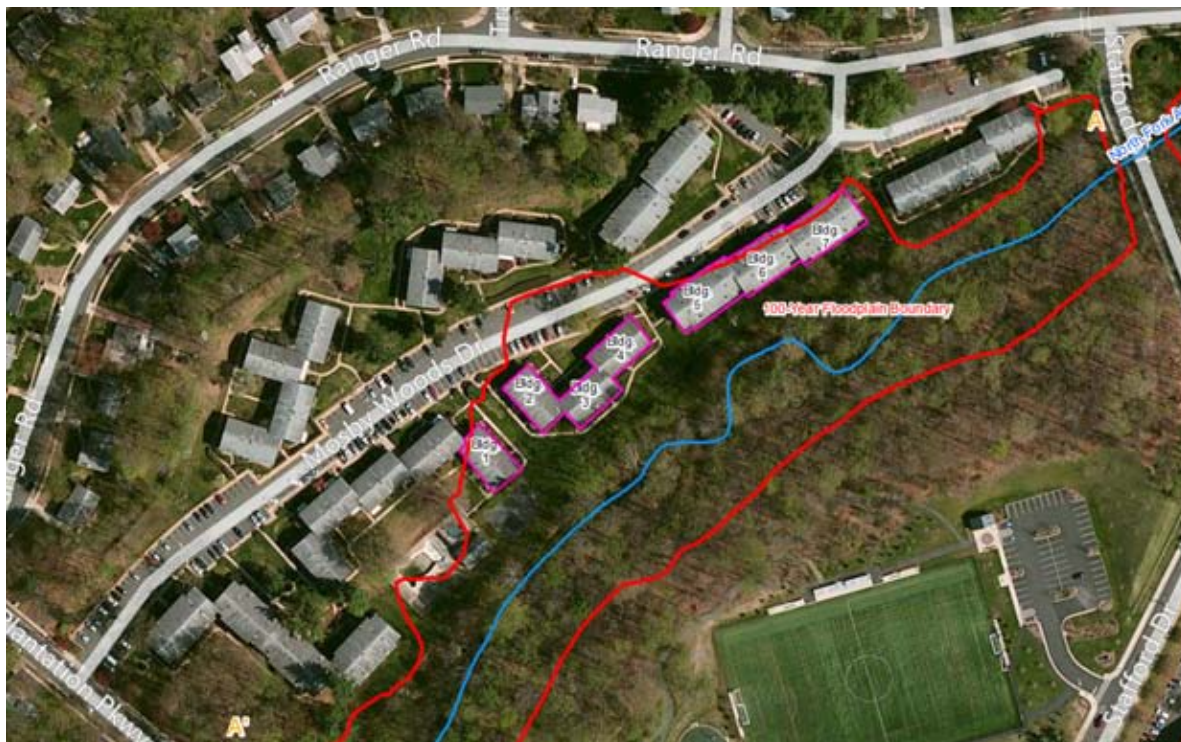
Figure 4-2. Buildings Affected by Historical Flooding at Mosby Woods Condominiums

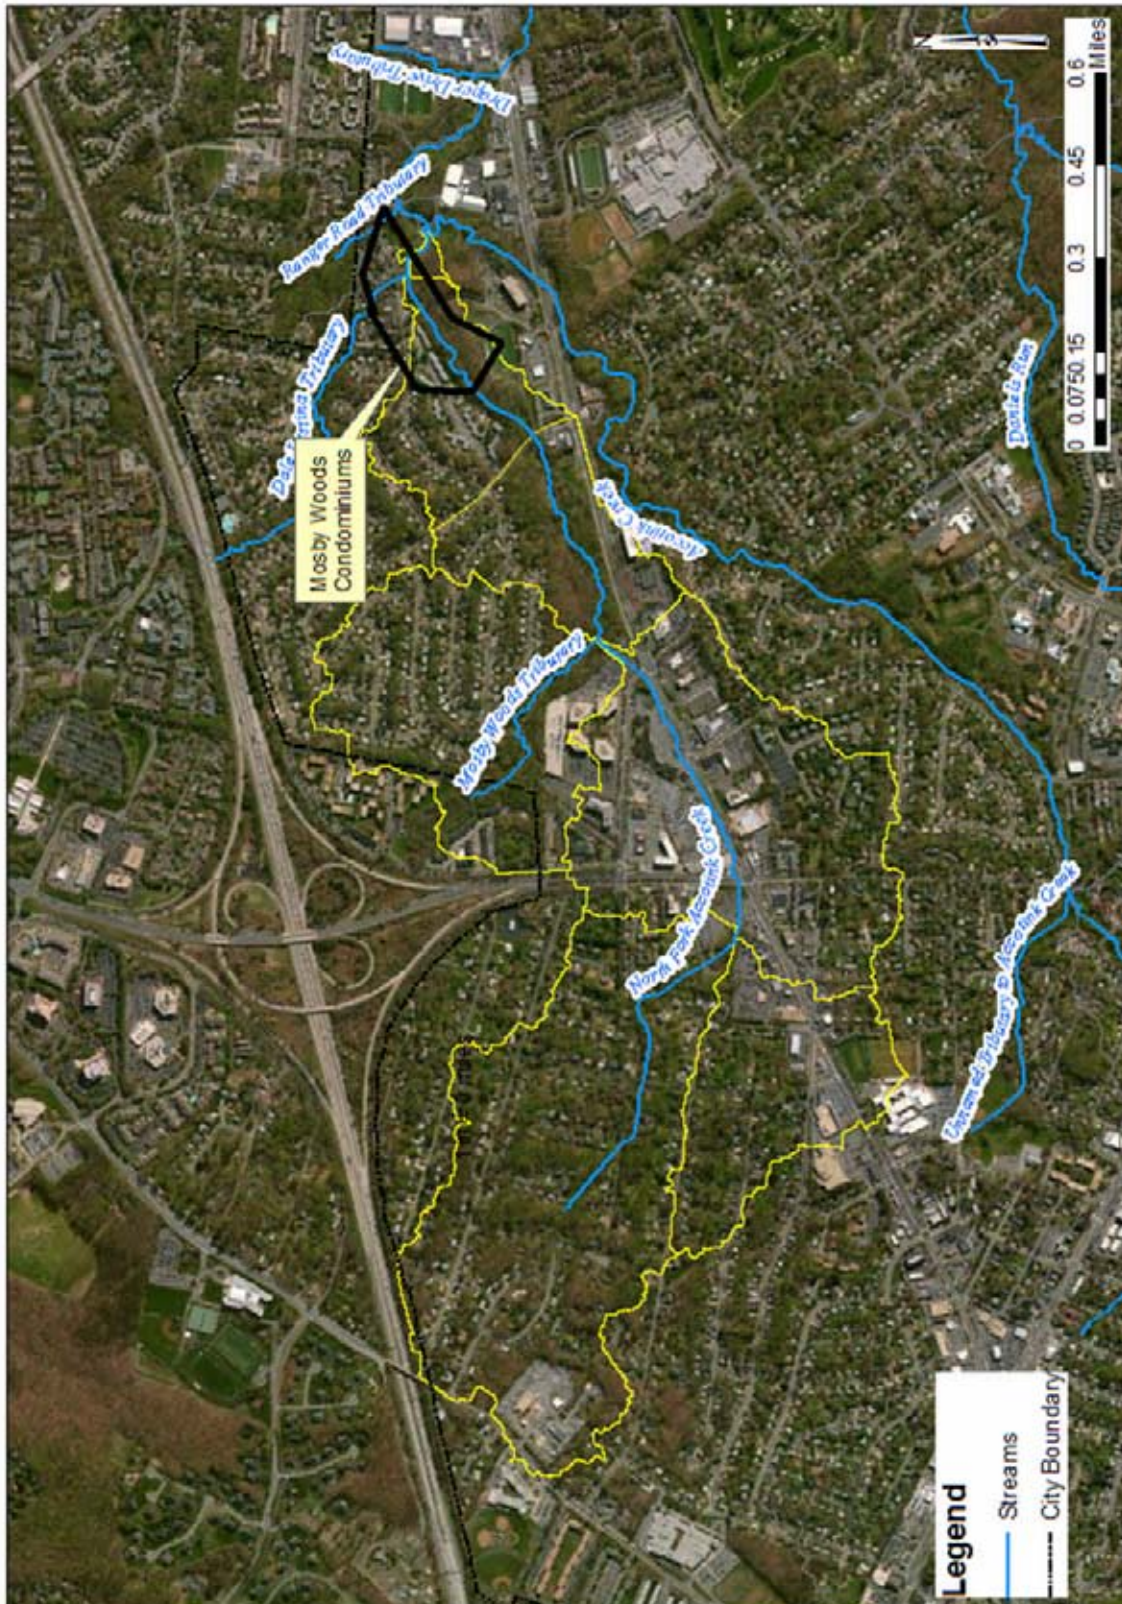
Figure 4-3. North Fork Accotink Creek Drainage Area Map

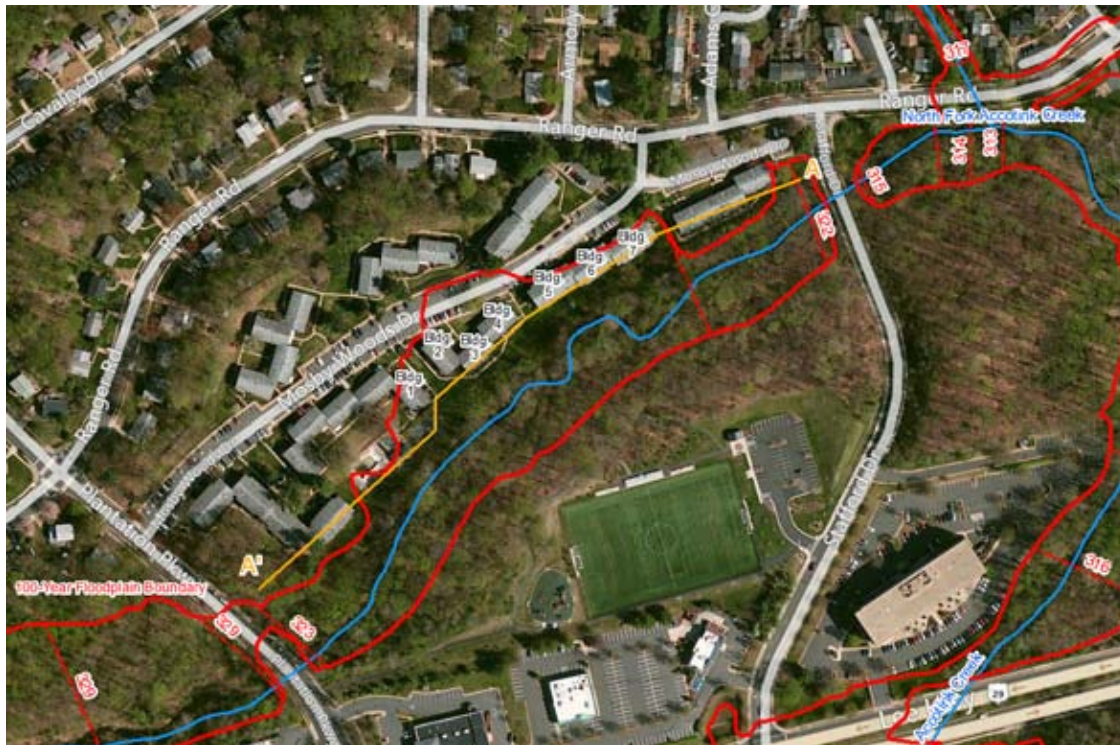
Figure 4-4. 100-Year Flood Boundary and BFEs at the Mosby Woods Condominiums

Base water surface elevations (also known as BFEs) for cross-sections in the vicinity of Mosby Woods are provided in **Table 4-2** below. Cross-Section locations are represented on the FIS profile shown in **Figure 4-5**. The BFEs indicate the water surface elevation of the 100-year floodplain at the cross-section location. It is noted in the FIS that floodways were not calculated for any stream in the City of Fairfax.
